# Manhole Inspection Summary

Manhole # S03WW1013MH

**Location** Address: **3501 DEVONSHIRE DR**

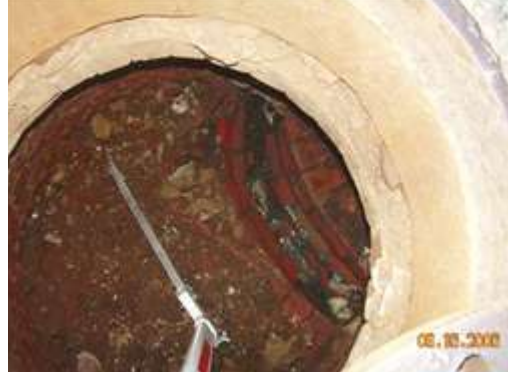
Top View

Frame leaks. Adjustment deterioration, loose brick and infiltration.

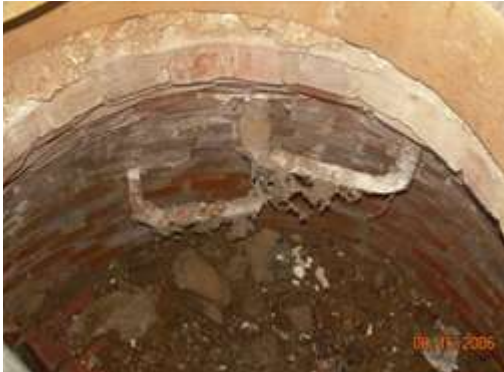
Defect

Frame leaks. Adjustment, Corbel, and Barrel infiltration. Bench debris.

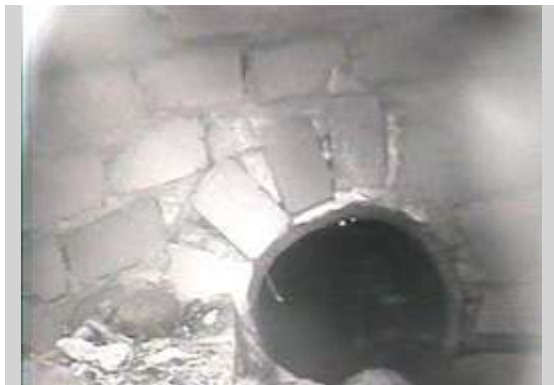
Pipe Out @ 12 O'Clock

Infiltration: **Evidence** Pipe Seal Cond: **Cracked**

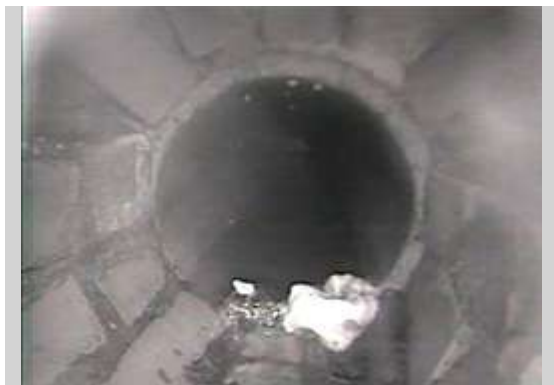
Pipe In @ 4 O'Clock

Infiltration: **Evidence** Pipe Seal Cond: **Unknown**
